SPACE SHUTTLE HOLDDOWN POST BLAST SHIELD

F. B. Larracas*

ABSTRACT

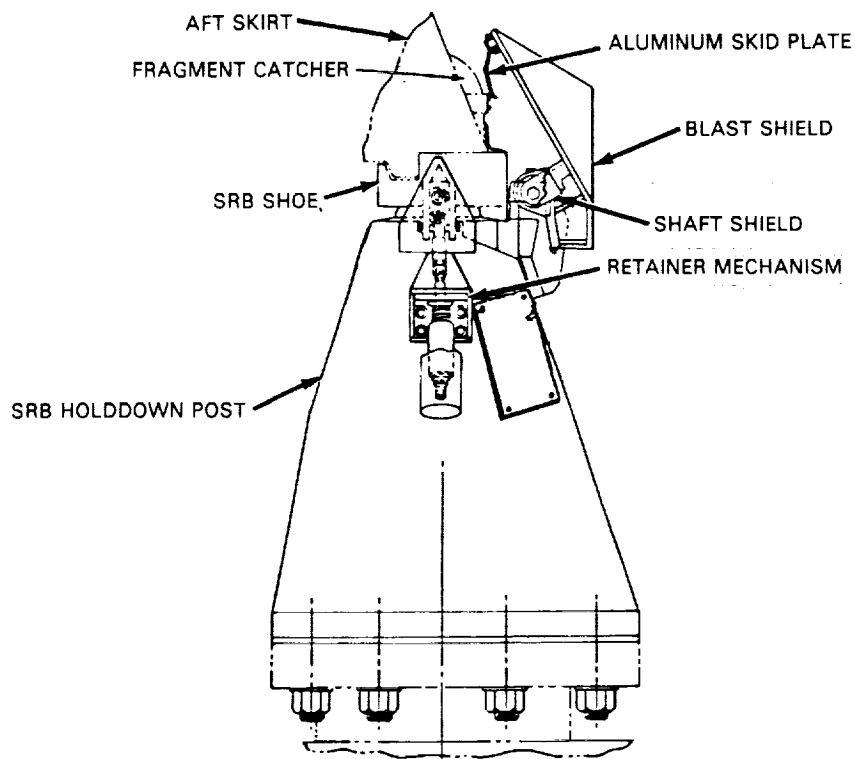
Figure 1. Holddown Post Blast Shield Installation (Original Design)

The blast shield is a mechanism that is attached to the holddown post with mount brackets which also act as hinges (see figure 1). The shield rests against the fragment catcher of the frangible nut prior to launch. It is spring loaded, and during lift-off of the Space Shuttle, the front edge (skid plate) "cams off" the fragment catcher. This action increases the spring tension which causes the blast shields to close after separation from the SRB aft skirt. As its name implies, it shields the shoe, the top of the holddown post, and the spherical bearing from the hostile environment of the SRB's exhaust plume.

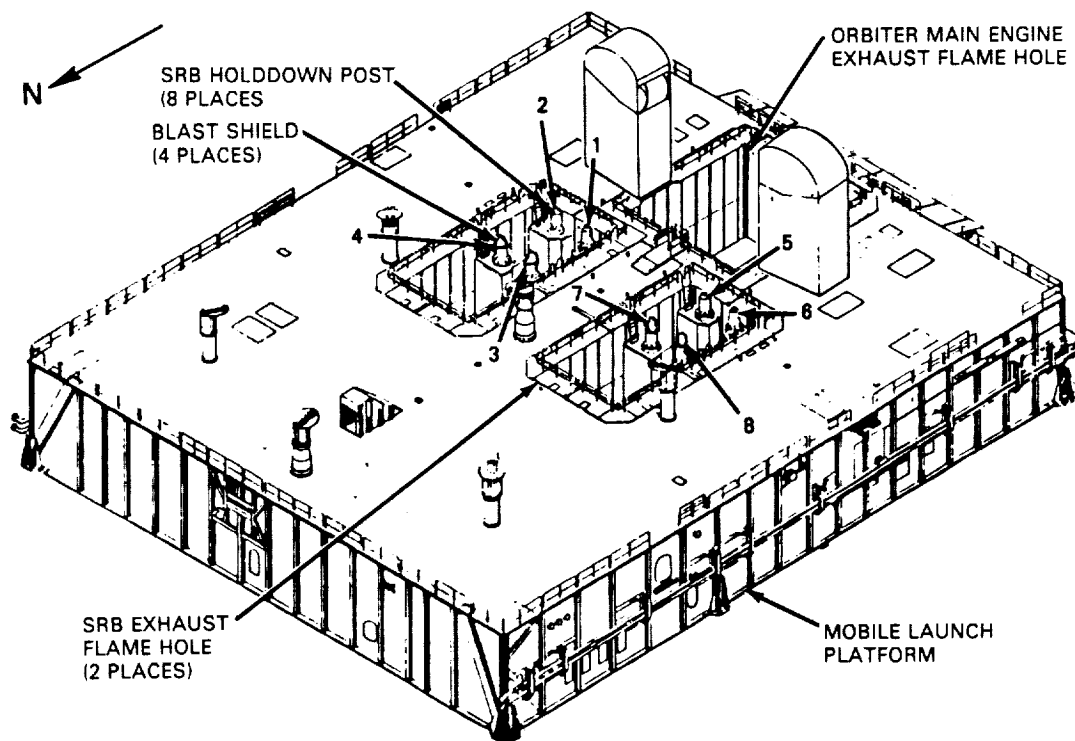
Figure 2. Blast Shield Locations on the Mobile Launch Platform

Because of the northerly drift angle of the Space Shuttle during lift-off, the north holddown posts (numbers 3, 4, 7, and 8) sustain the majority of the blast damage. Consequently, blast shields are installed only on these posts (see figure 2).

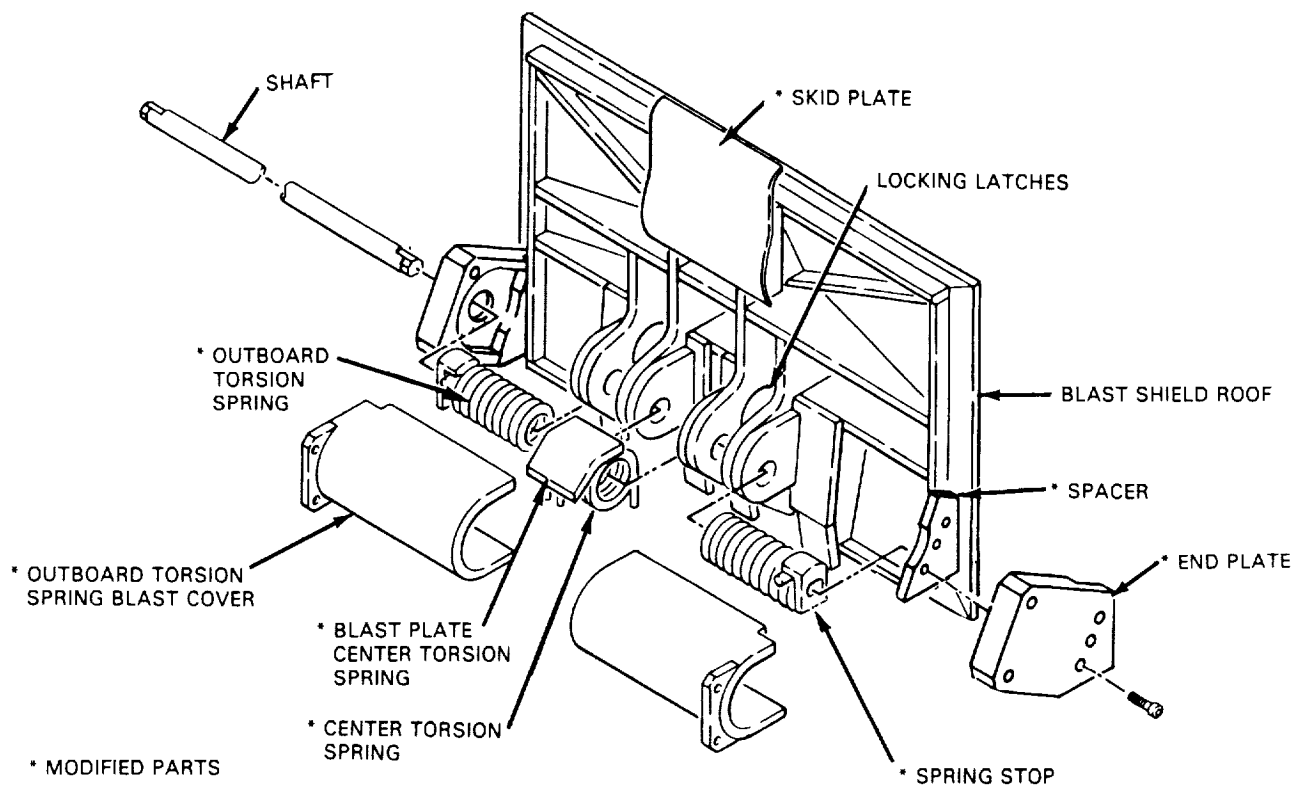
Figure 3. Blast Shield Modification and Installation

Between January 1987 and September 1988, the blast shield underwent an extensive modification program. Once again, the primary concern was strengthening the areas of the design contributing to the release of debris. Thus, redesign efforts focused on ensuring proper closure of the blast shields, eliminating the kick spring/plunger mechanism that proved so susceptible to launch blast, and modifying the design wherever possible to minimize blast impingement.

Accordingly, the blast shields were modified as follows (see figure 3):

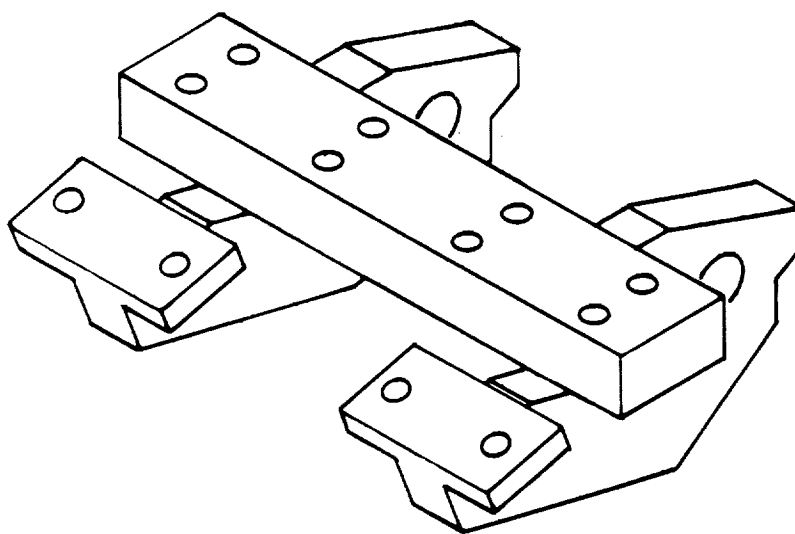
Figure 6. Mount Bracket (Current Design)

The blast shield then underwent validation testing at KSC's Launch Equipment Test Facility (LETF). After testing, the blast shield was removed from the holddown post that was used as a test stand. One of the bottom base plates fell off . . . under a no-load condition! The cause was determined to be lack of weld fusion: a fillet weld was used instead of a bevel weld, as called for in the drawings. Grinding the fillet weld left about a 1.5-millimeter (0.06-inch) weld holding the foot to the vertical bracket. Additionally, several problems were associated with the use of welded 4140 parts, including a lack of established procedures and a lack of welders experienced in welding 4140 steel.

More recently, the use of casting was adopted to reduce fabrication costs. The first article casting was made and passed X-ray and magnetic particle testing. A second batch of four was then poured at the foundry. During the machining phase, the machinists observed that the second batch machined harder than the first article. After machining, the brackets were sent out for heat treatment. The brackets came back from heat treatment with large cracks, typically near the heavy sections of the brackets.

An analysis performed by the KSC Analysis Laboratory revealed that the cracks were caused by a higher than allowable carbon and manganese content in the alloy. The foundry's computer printout indicated otherwise. A second analysis performed by the foundry, however, confirmed the KSC findings.

As a result, the mount brackets were made out of a one-piece AISI 4140 steel billet. The billet was rough cut to a basic shape then machined to its final form in the annealed condition. Heat treatment and magnetic particle inspection followed machining.
